Re: *Risk-Based Disposal Application for PCB Remediation Waste*
1776 Constitution Avenue, Louisville, Ohio

On the behalf of MTH Holdings Corp. (MTH), ONE Environmental Group, LLC (ONE) herein submits this Risk-Based Disposal Application for PCB Remediation Waste in accordance with 40 CFR 761.61(c) and the Toxic Substances and Control Act (TSCA). The subject area is referred to as the "SB-09 source area" of the OTC Services (OTC) facility located at 1776 Constitution Avenue Louisville, Ohio. A Site Location Map and a Site Map are provided as **Figure 1** and **Figure 2**, respectively. It should be noted that CRC Ohio Properties LLC (CRC) is the owner of the subject property that is currently occupied by OTC Services (OTC); however, MTH is contractually obligated to complete the cleanup work.

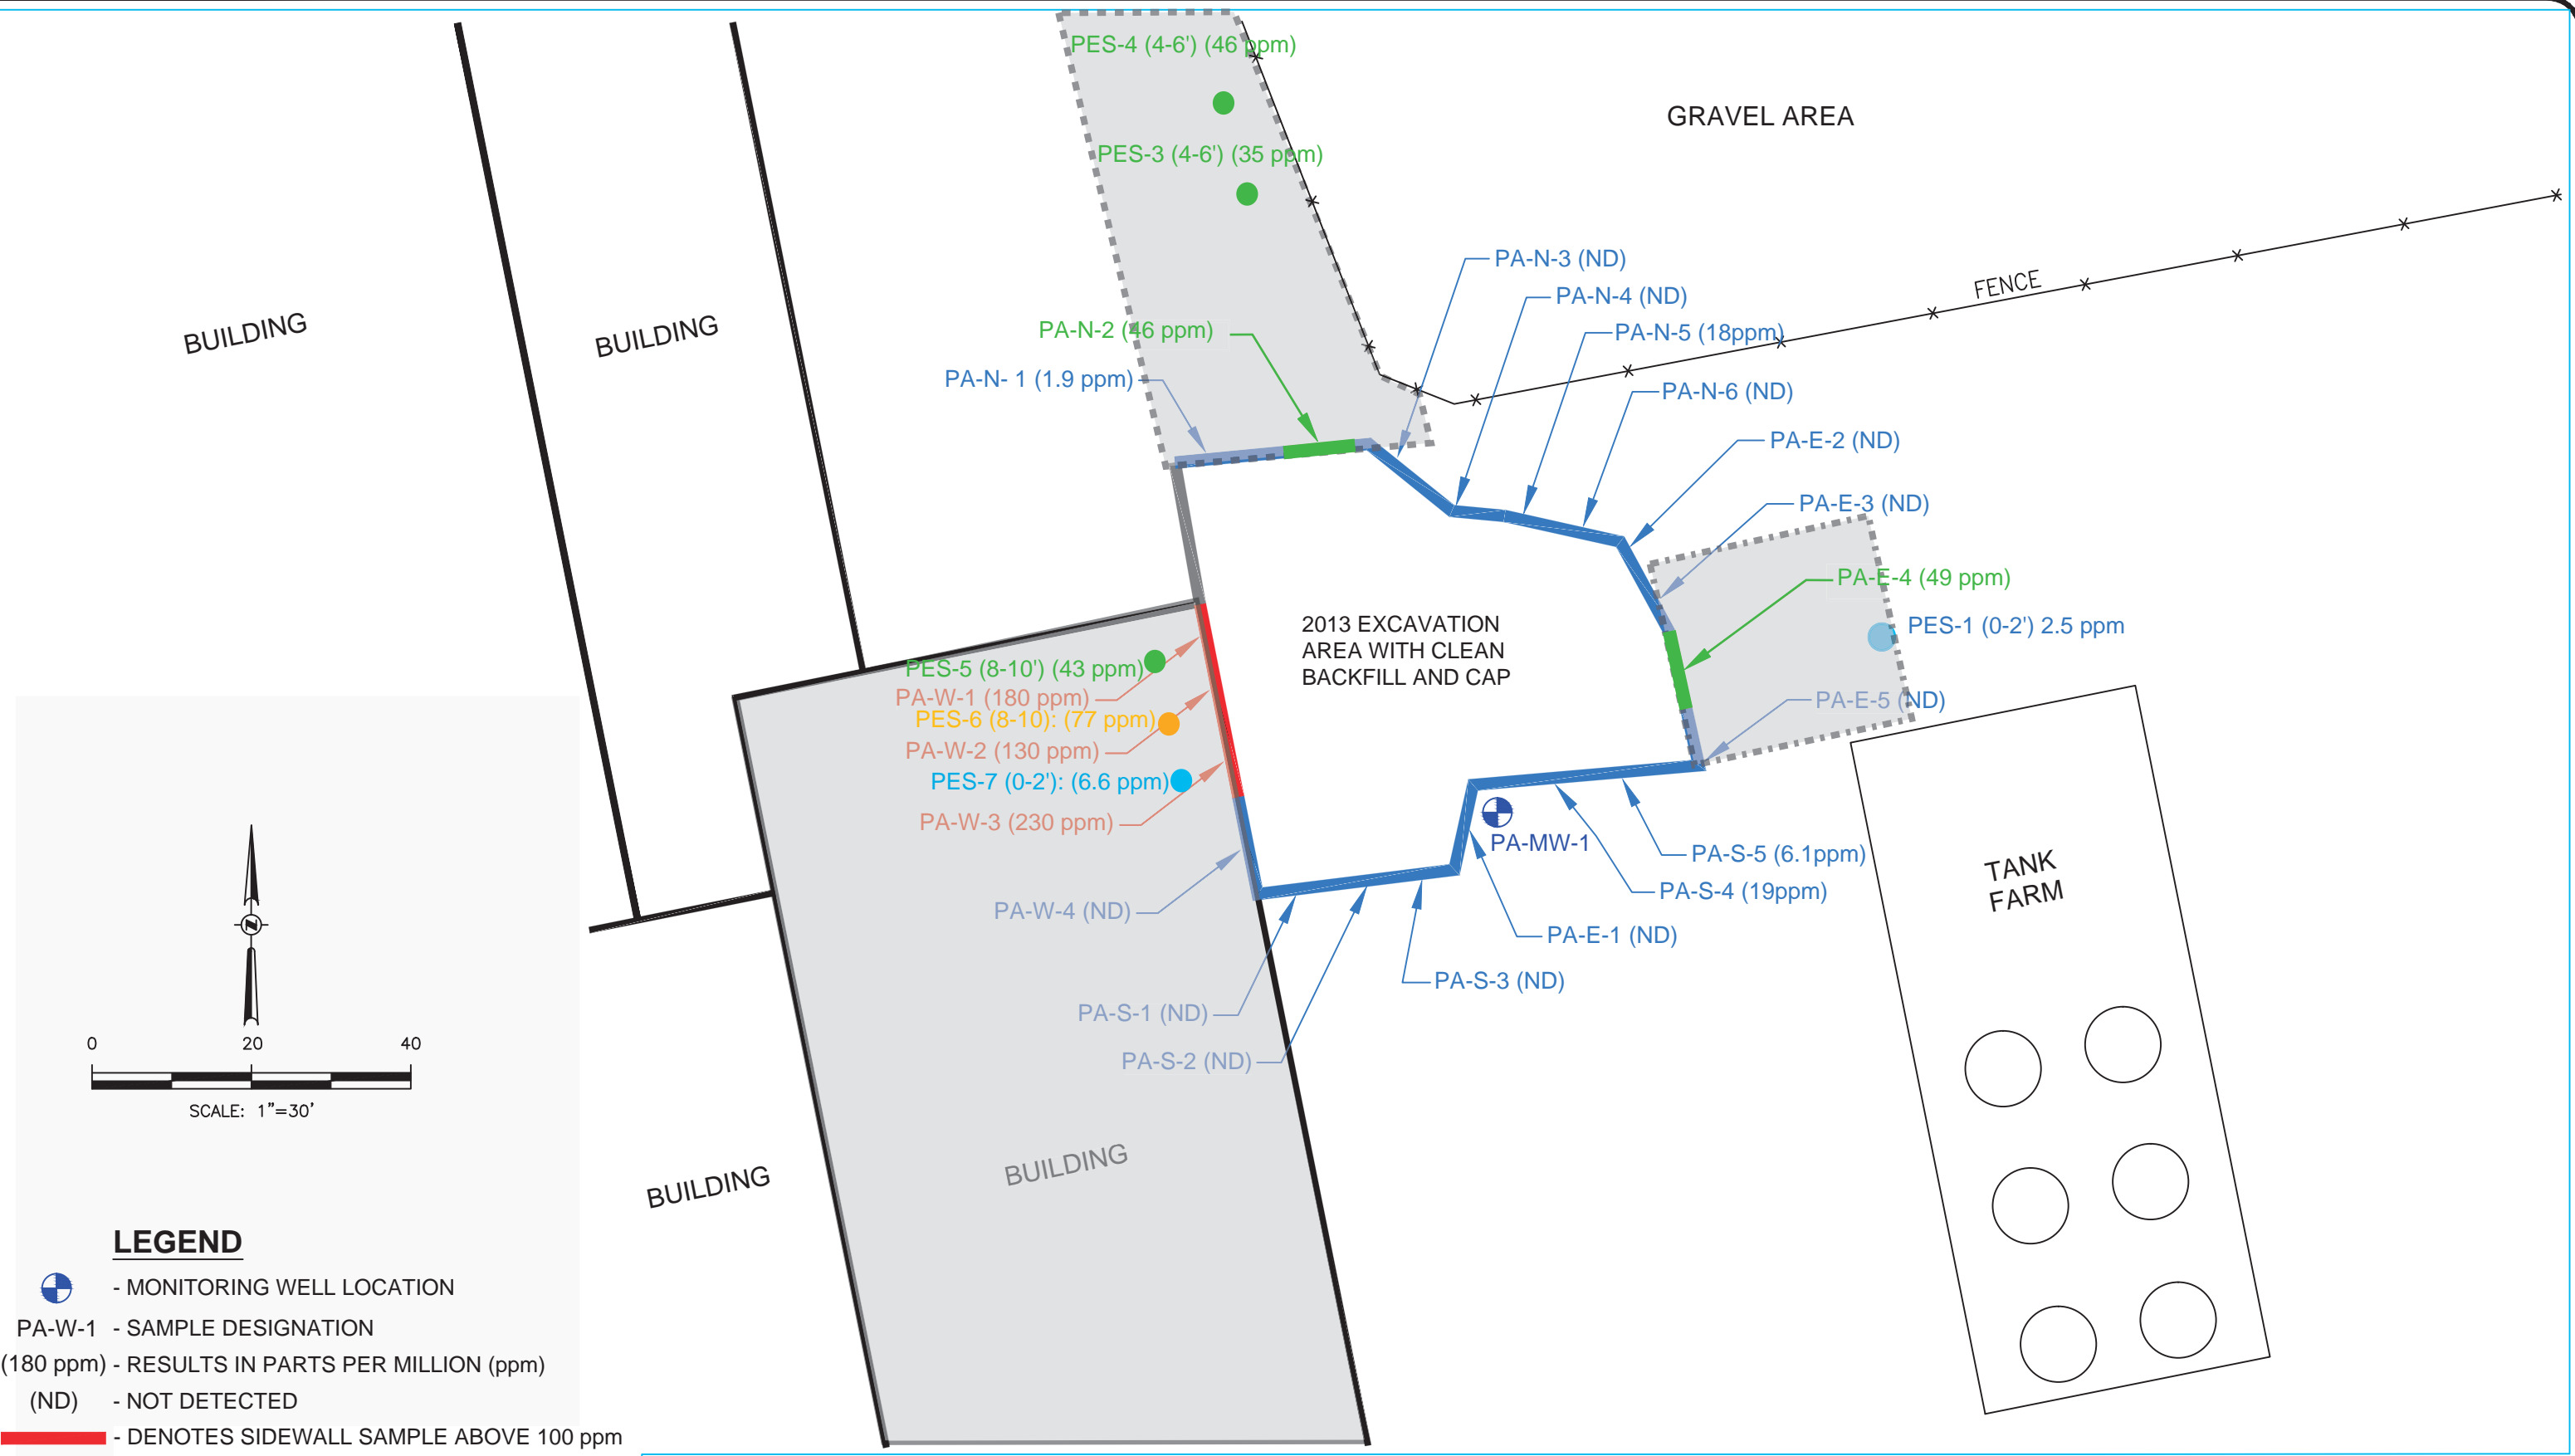
Drawn By:	LEC	Date:	10-7-13
Checked By:	EH	Revision Date:	
Acad File No.: site map 2013.dwg	Figure No.: 3		
Project No.:

On July 18, 2013, ONE submitted to the USEPA the *Update on Self-Implementing Cleanup Activities and Notification of Proposed Changes to the PCB Cleanup Plan* letter (herein referred to as the “Update Letter”) which documented the excavation and disposal of PCB-impacted soils and confirmation soil and groundwater sampling. The extent of the excavation work and the results of the sidewall sampling are depicted on **Figure 3**.

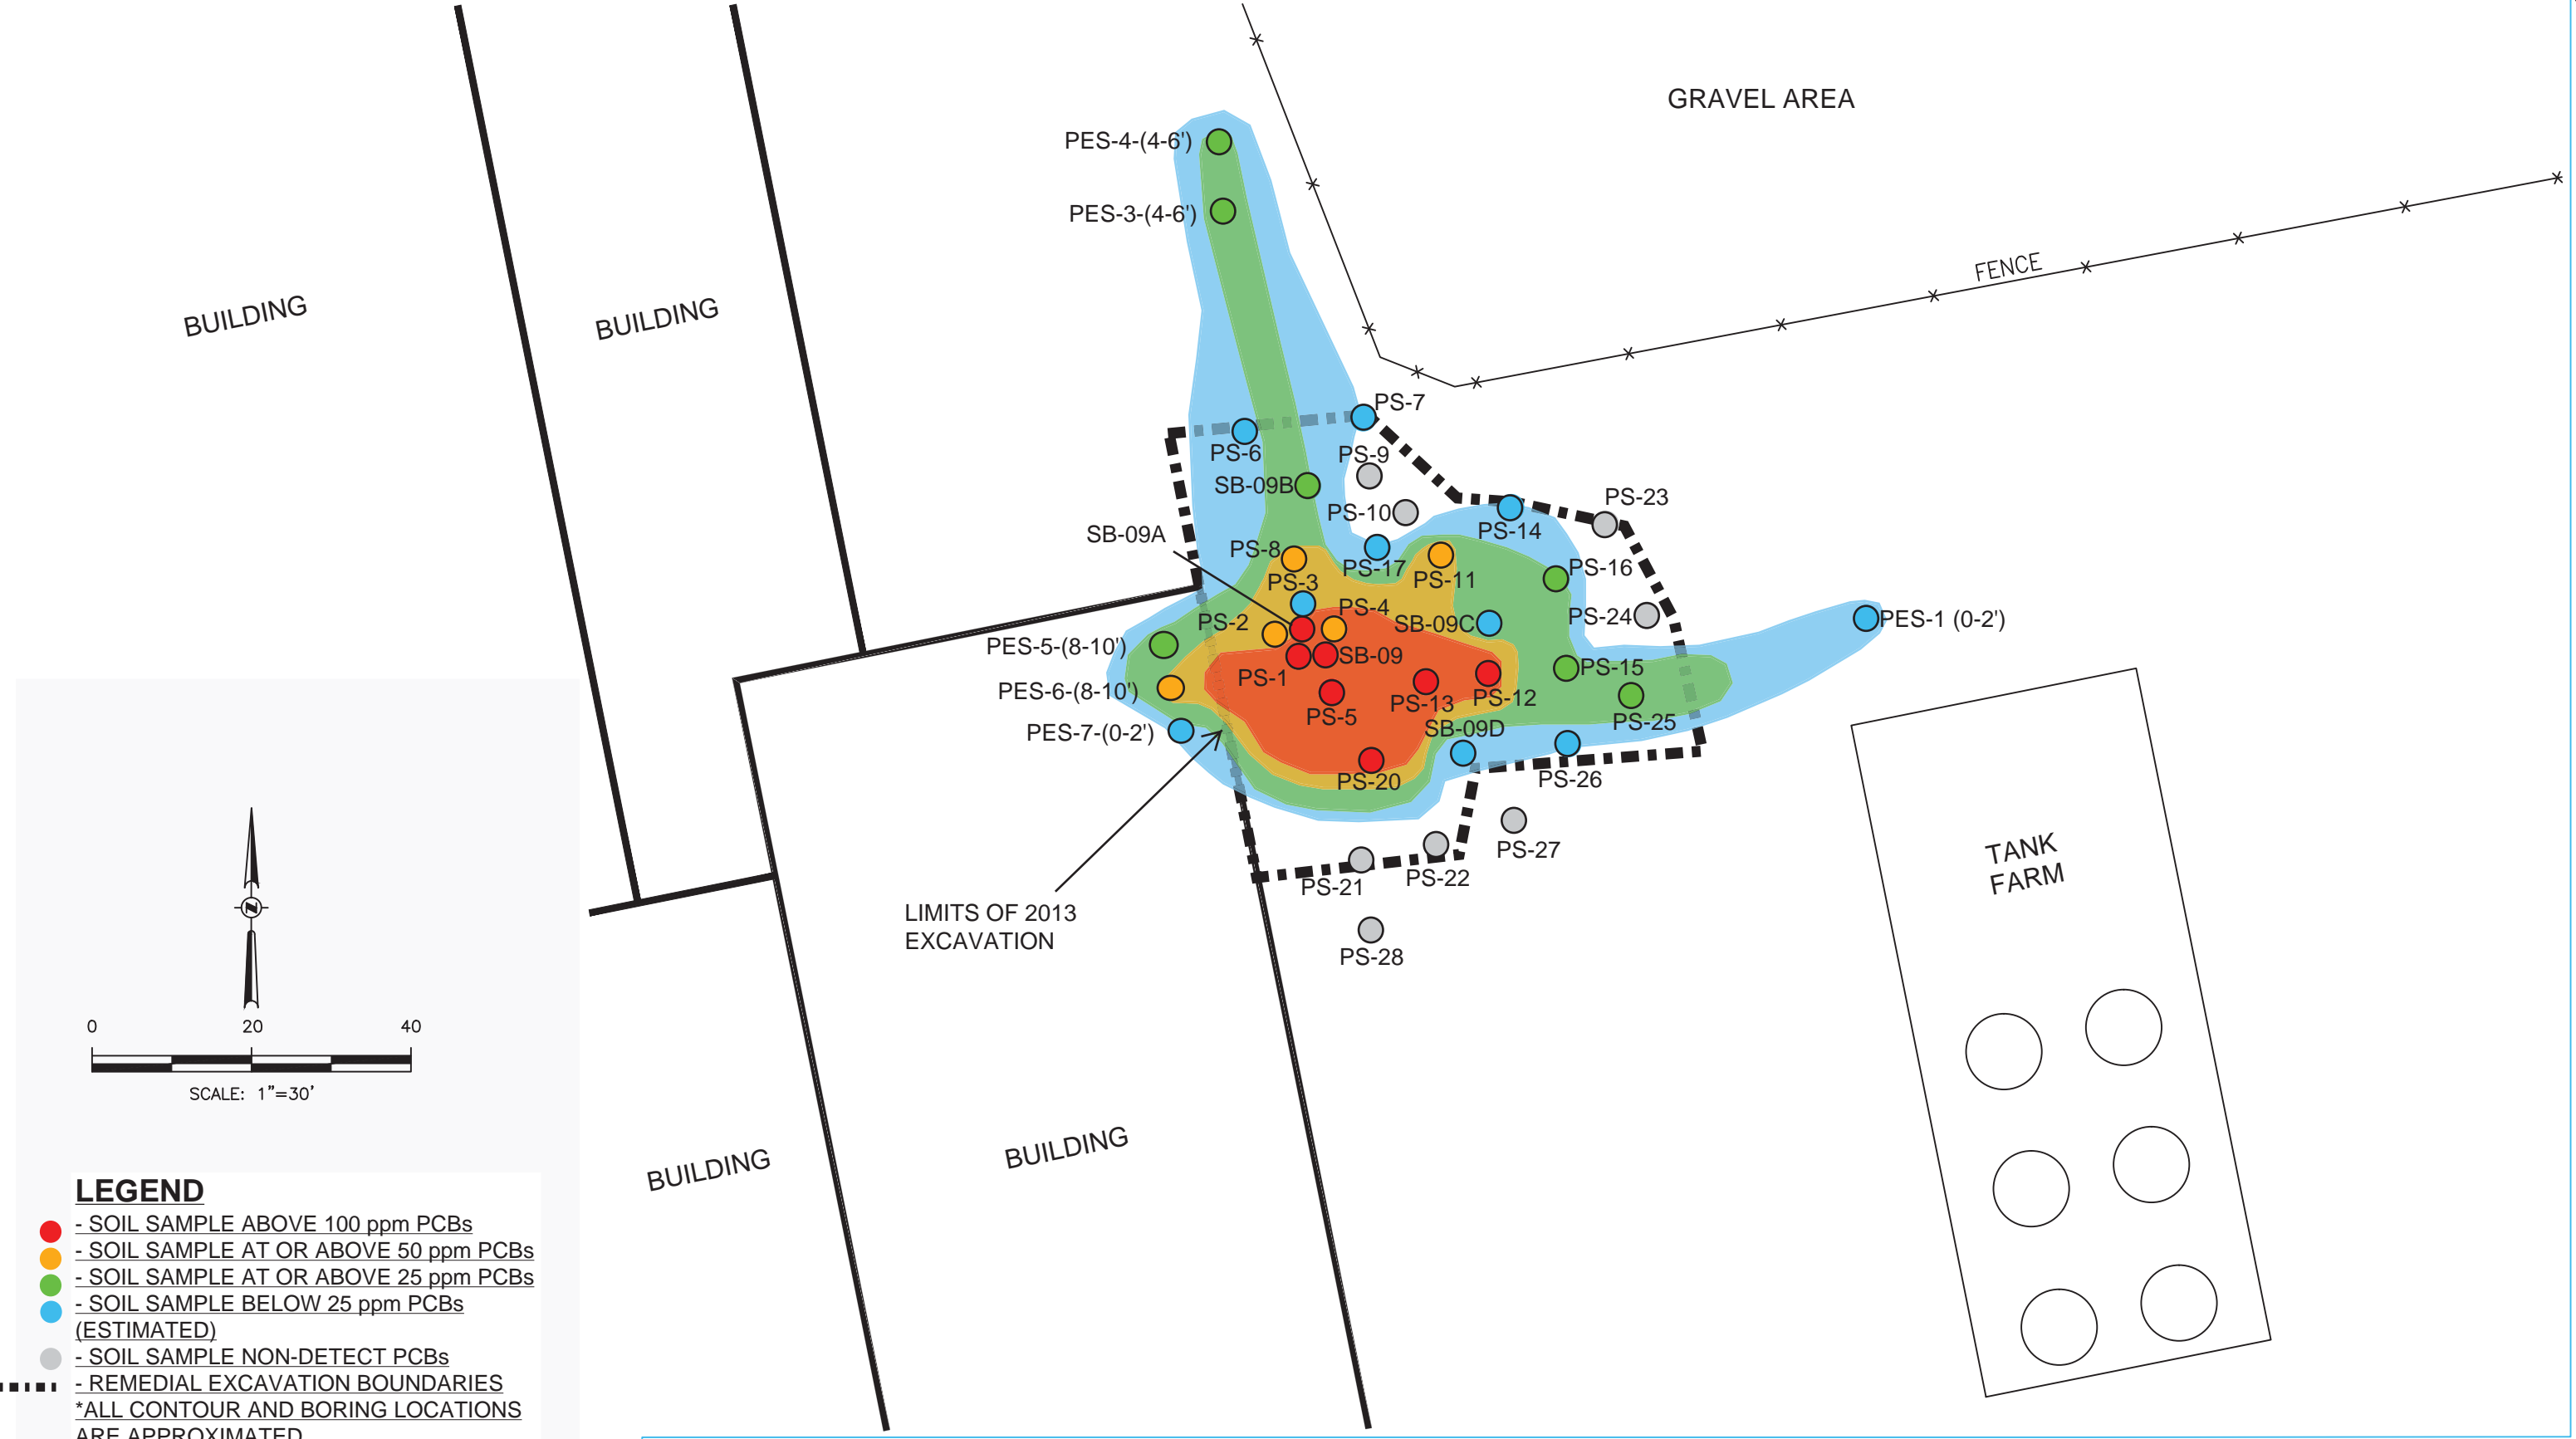
Drawn By:	LEC	Date:	09 - 30 - 13
Checked By:	EH	Revision Date:	
Acad File No.: site map 2013.dwg	Figure No.: 4		
Project No.:

Based on the results of the additional sampling, PCB levels along the fringes of the excavation have decreased significantly from >1000 ppm located in the SB-09 source area to concentrations less than 50 ppm. Concentrations of PCBs below 50 ppm but above 25 ppm are isolated to the north and west of the former source area within low-occupancy areas. PCB concentrations less than 10 ppm are confirmed to the south and east of the former source area. An isoconcentration map of the PCB concentrations reported in soil samples collected over the course of this project has been developed and is presented as **Figure 4**. Based on these contours, it is clear that the PCB source area has been removed (excavation boundary depicted by the black dotted line) and PCB levels have decreased dramatically indicating that no additional sources are located in this area of the site.

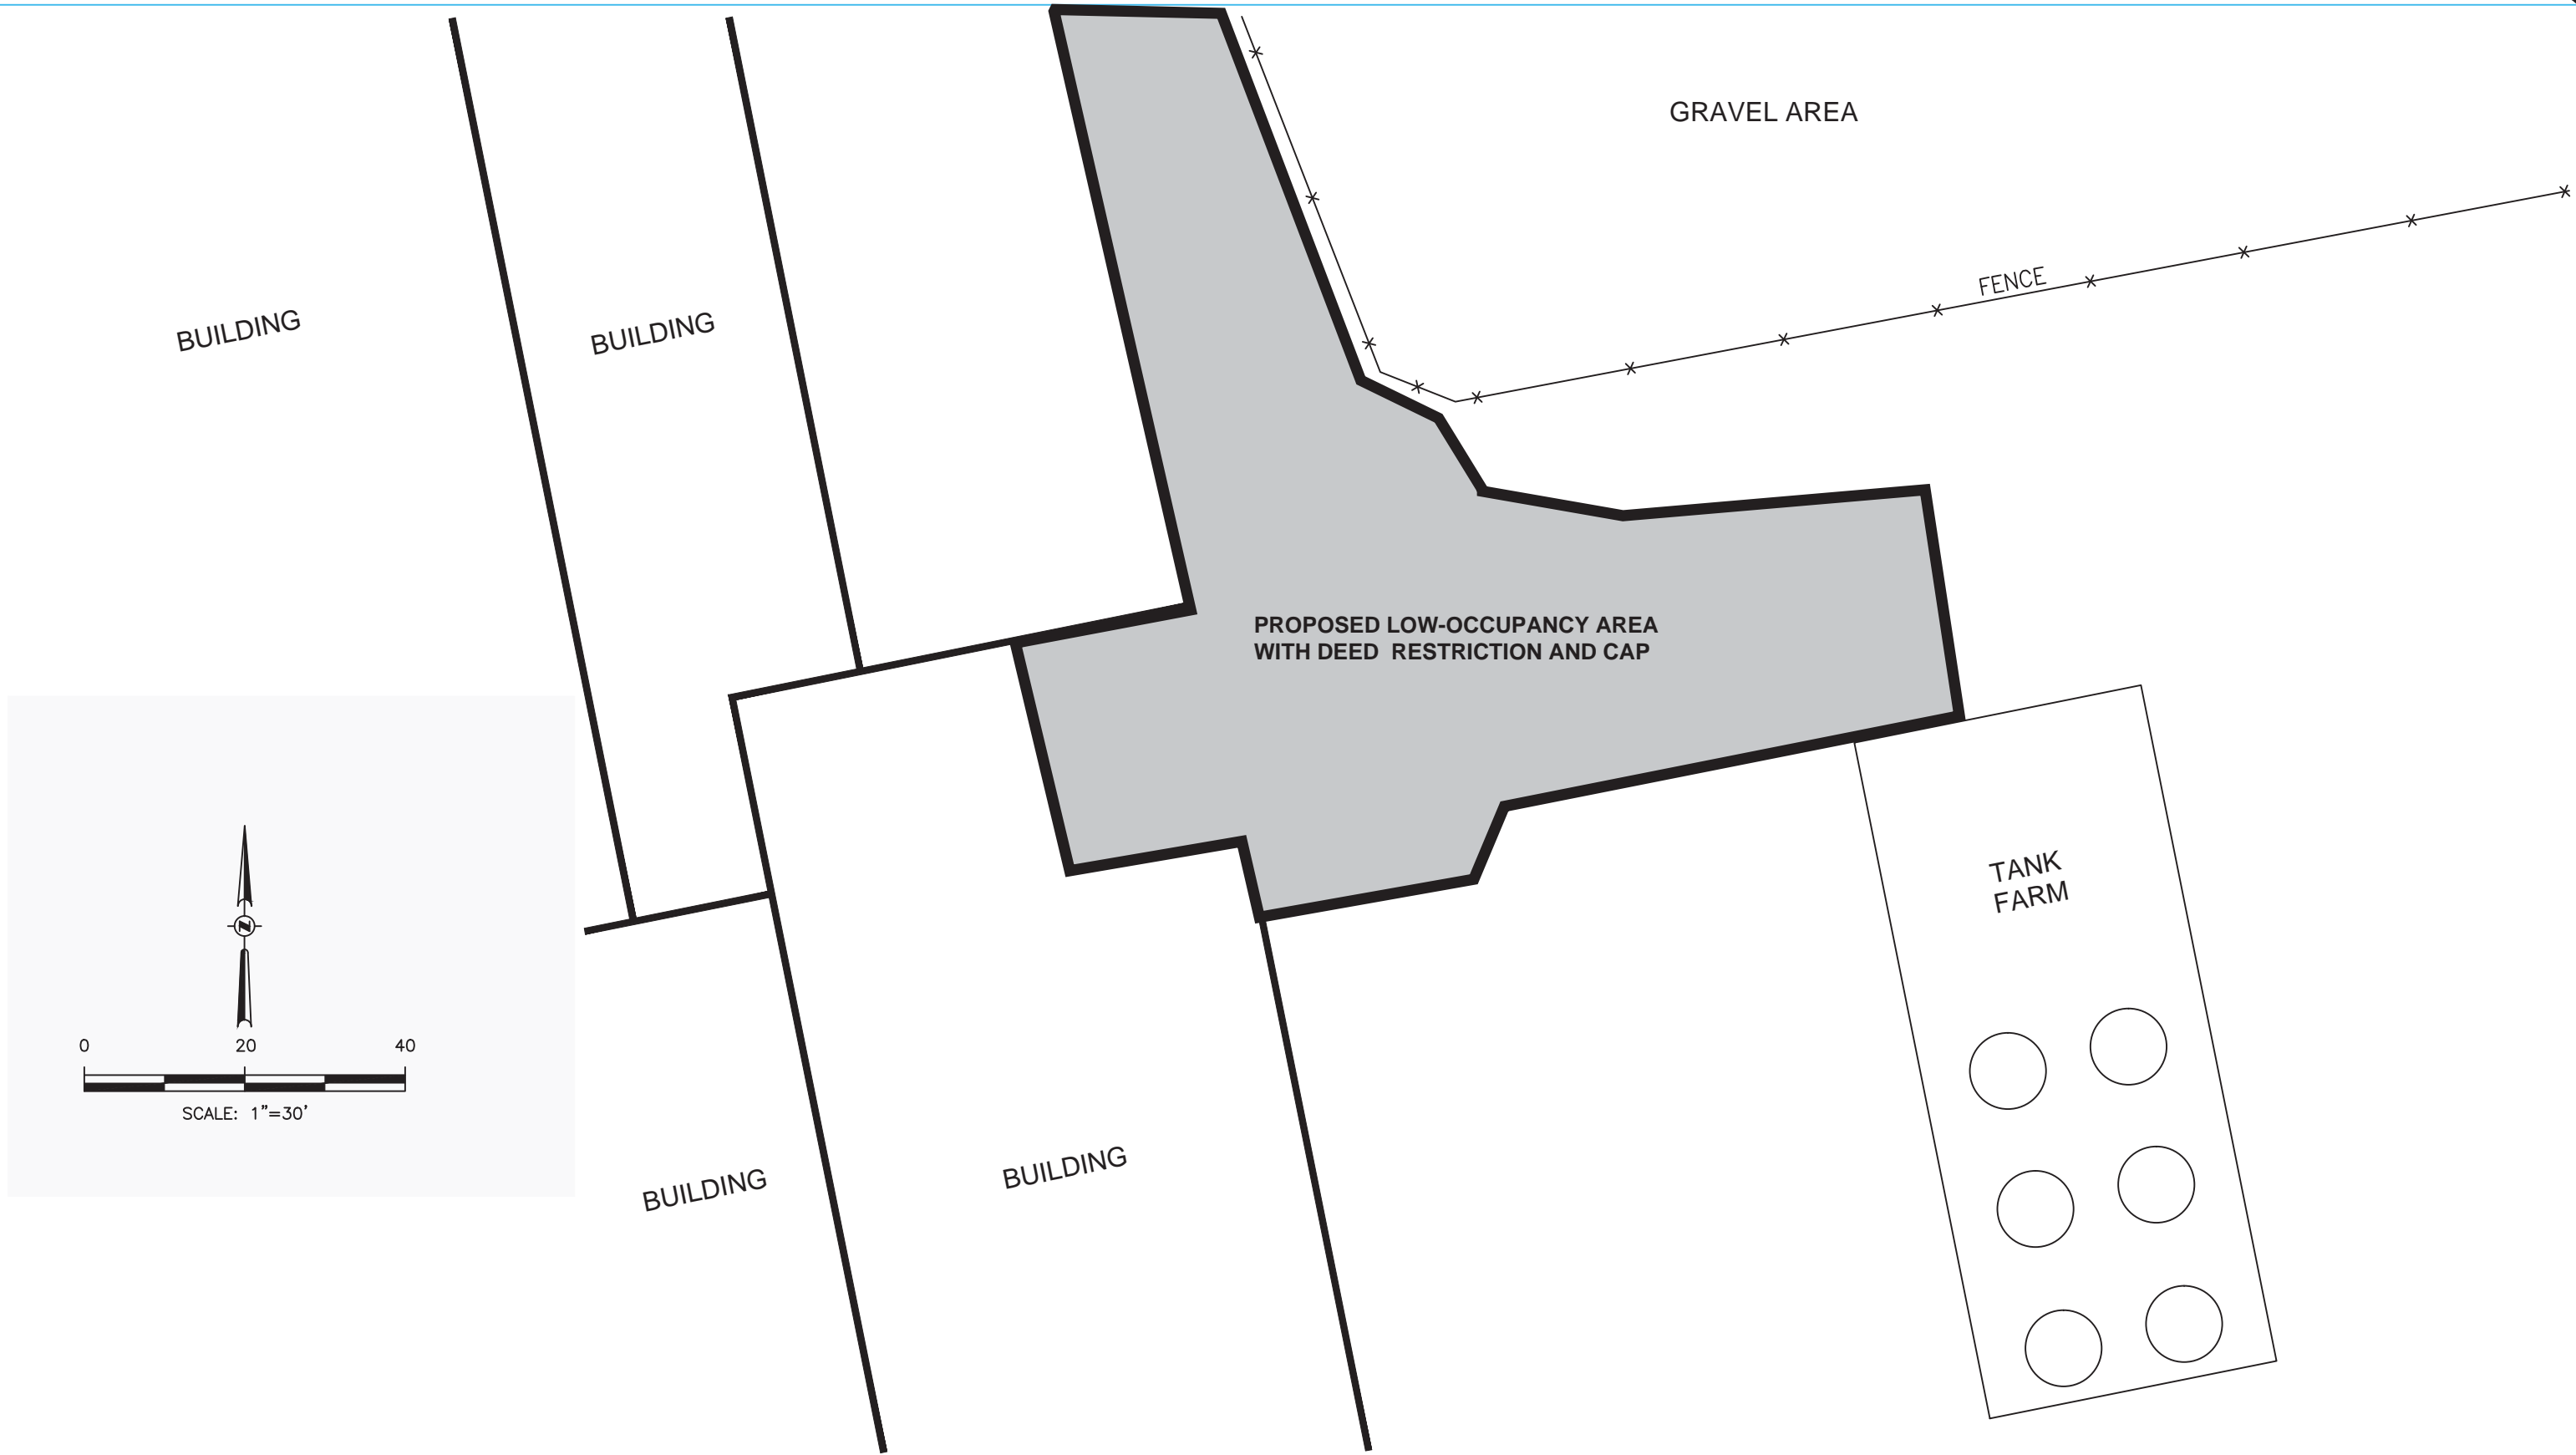
Figure 5 indicates the areas that will require both engineered controls (i.e., caps) and institutional controls (i.e., deed restrictions).

□ - DENOTES PROPOSED LOW-OCCUPANCY AREA WITH DEED RESTRICTION AND CAP

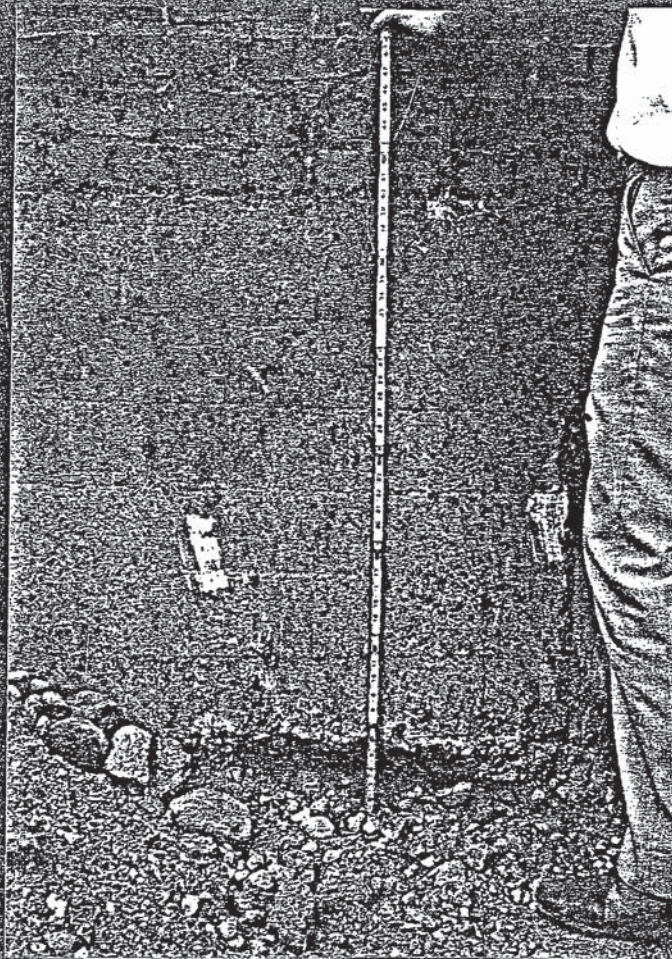
The excavation along the building at the west side of the pit exposes a portion of the foundation but basically, is at a depth no greater than the bottom of the foundation. This foundation is a grade-wall with no

| 4A | Photo looking west at building wall (shown in Photo 4) showing exposed building foundation wall. |

In conclusion, then, this office recommends that no further excavation proceed along the driveway and building projection. Also, it is recommended that any excavation along the building at the west side of the pit be executed as noted above. Further, a plastic film should be provided to protect areas of over-cut as noted above.

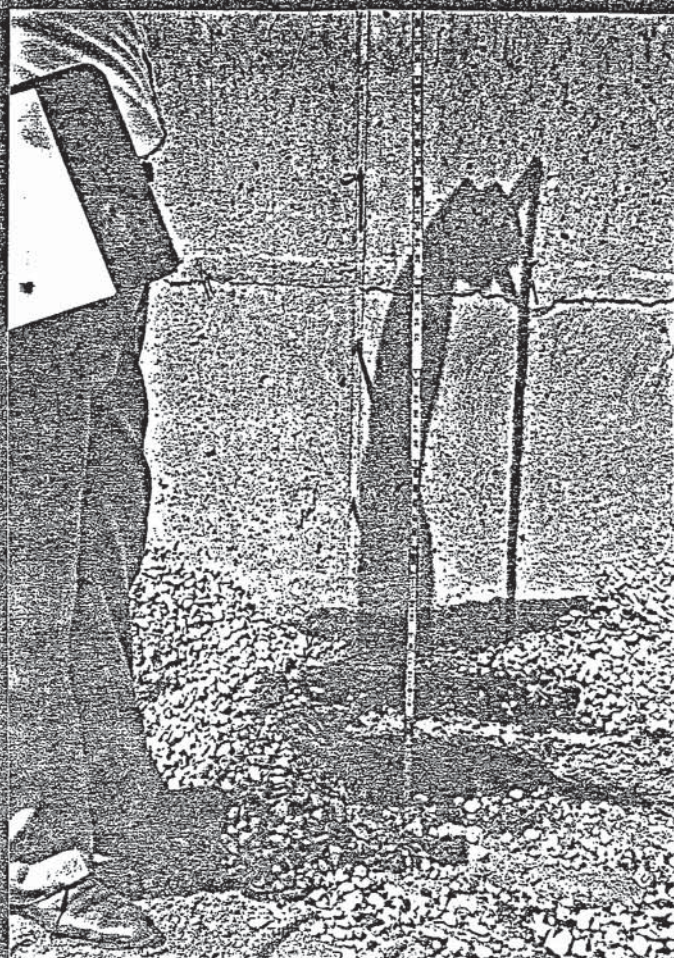
| 4B | Photo showing detail of exposed building foundation wall (from Photo 4A). |

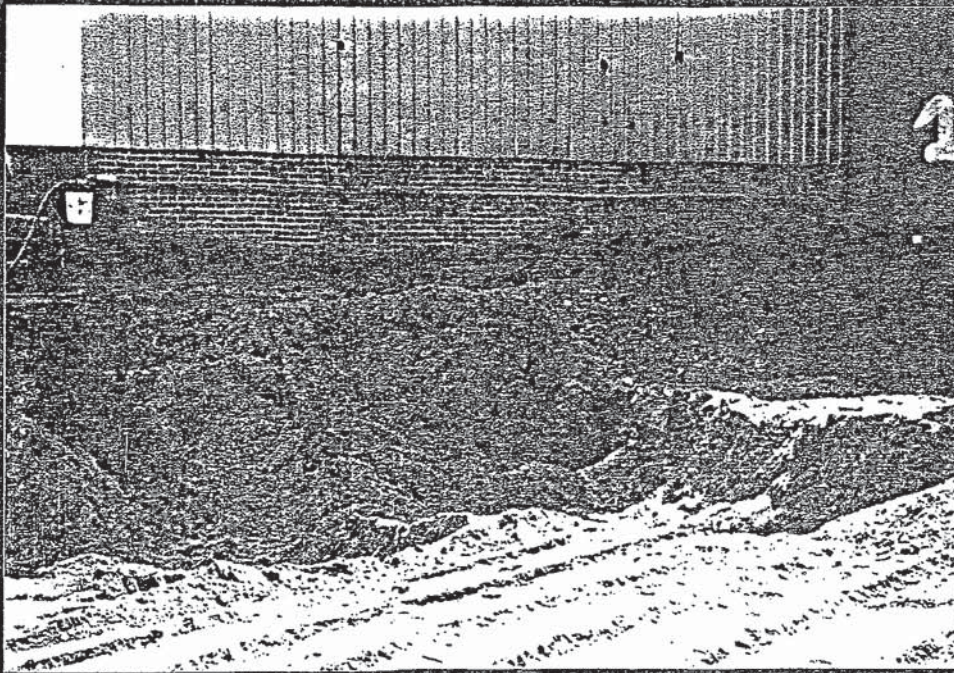
| 7 | Photo looking south at corner of building showing exposed building footer. |
